**Environmental
Assessment
Study for Portage
Parkway (Part A
and B)**
Safety Review of Existing
Conditions

B000541

August 2015

City of Vaughan

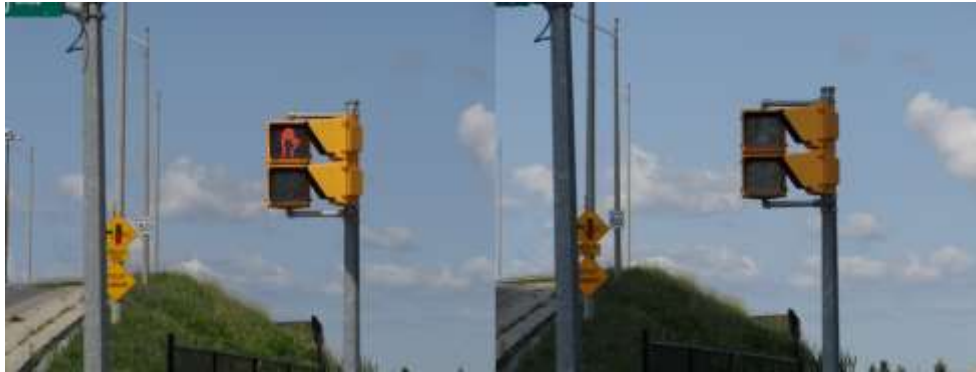
Figure 3 : Malfunctioning Pedestrian Signal Head

4.1.1 Malfunctioning Pedestrian Signal Head

The existing traffic signal head located in the northwest quadrant of the intersection of Applewood Crescent and Portage Parkway contains a malfunctioning pedestrian signal head facing the

westbound pedestrians. The signal head does not display the pedestrian walk cycle, although the signal head works properly during the “Flashing Don’t Walk” (flashing hand) and “Don’t Walk” (stead hand) phases. The issue is illustrated in Figure 3. The photo on the right side was taken during the pedestrian walk cycle.

- + Repair the malfunctioning pedestrian signal head located in the northwest quadrant of the intersection;
- + Install Object Marker Signs on Guiderails on both sides of the west approach of the intersection; and
- + Improve the turning radius for facilitating the westbound right turn movement for heavy vehicles.

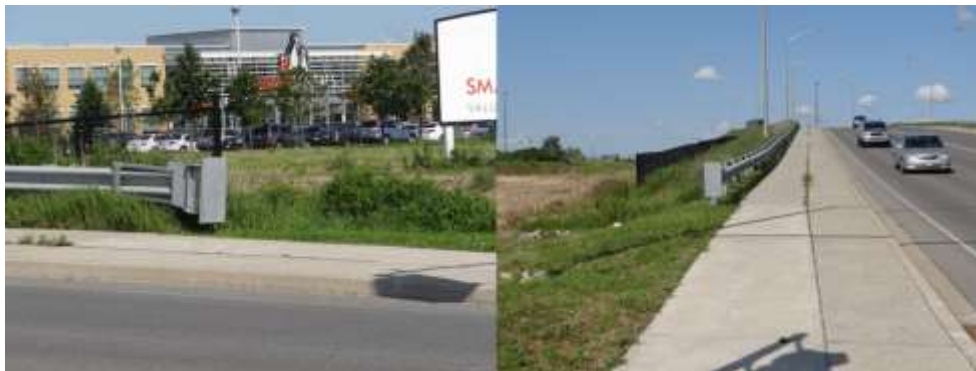
Figure 4 : Missing Object Marker Signs

4.1.2 Missing Object Marker Signs on Guiderails

The existing guiderails located on both sides of the west approach of the intersection of Applewood Crescent and Portage Parkway contain missing Object Marker warning signs for the westbound traffic as demonstrated in Figure 4. The subject guiderails currently have extruders installed with available surface space for the installation of object marker signs (Wa-33L & Wa-33R) on either side of the guiderails.

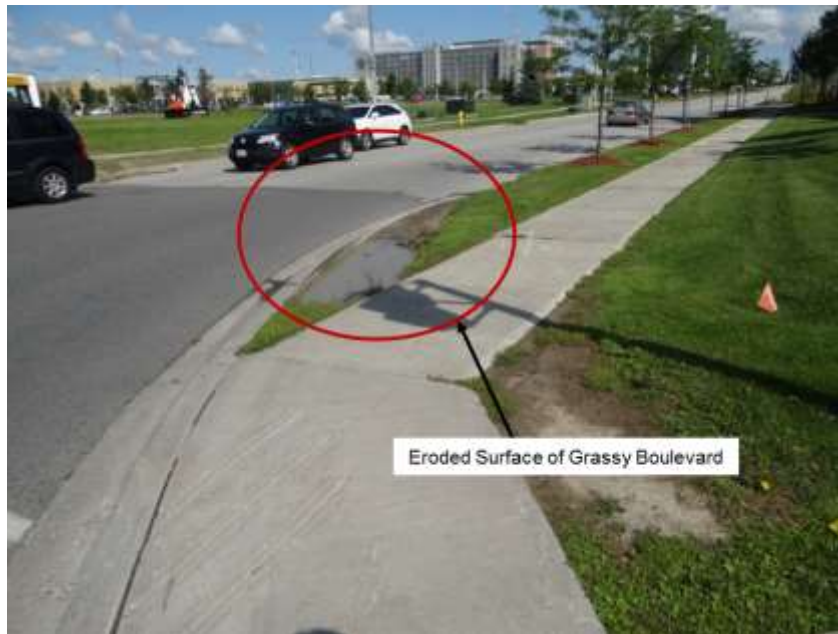
Figure 5 : Eroded Grassy Boulevard Resulting from Repeated Encroachment by Heavy Vehicles

4.1.3 Limited Turning Radius for Heavy Vehicles

Heavy vehicles attempting to make a westbound right turn from Portage Parkway onto Applewood Crescent are forced to drive over the sidewalk and grass due to the limited available turning radius. We noted a few cases, when the rear wheels of large heavy vehicles climbed the curb and encroached onto the grassy boulevard close to the sidewalk. This situation creates a potential safety hazard for pedestrians on the northeast corner. Figure 5 demonstrates the eroded surface of the grassy boulevard due to repeated encroachment by trucks.

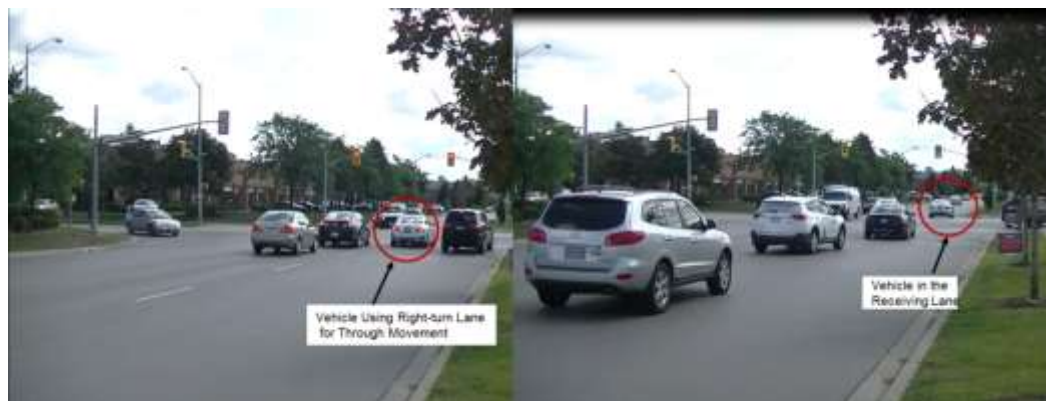
Figure 6 : Lane Configuration

4.2.1 Improper Lane Use

The existing lane configuration at the intersection of Edgeley Boulevard and Portage Parkway in the east-west direction is not appropriate. On the west approach (eastbound direction), the intersection consists of two lanes. The left lane is designated as a shared straight through & left-turn lane and the right lane is designated as an exclusive right-turn lane. In order to accommodate this configuration, there is only one receiving lane on the east approach as required. The issue is that the right-turn lane is almost double the width of the left lane and can easily accommodate two lanes of vehicles as demonstrated in Figure 6.

As a result, there are often two lanes of through vehicles and one lane of right turning traffic as demonstrated in left photo of Figure 6. However, there is only one receiving lane of normal width on the east approach as demonstrated in the right photo of Figure 6. This situation often creates a hazardous situation and potential of sideswipe collisions between two through lanes of vehicles that are destined to the same receiving lane.

- + Improve lane configuration of the intersection of Edgeley Boulevard and Portage Parkway by widening the portion of Portage Parkway east of Edgeley Boulevard to four lanes, which is the purpose of the proposed study. As a short-term remedy to the confusion caused to motorists due to current configuration, the pavement markings within this area can be improved in both directions. The existing Right Lane Exits sign (Wa-56R) can be moved to a point upstream of the noted private driveway providing access to the loading bay of LOWE'S Home Improvement Warehouse;
- + Improve the turning radius for facilitating the northbound right turn movement for heavy vehicles; and
- + Provide Accessibility for Ontarians with Disabilities Act (AODA) compatible pedestrian facilities (e.g. tactile surface provided at curb ramps should be aligned with crosswalks).

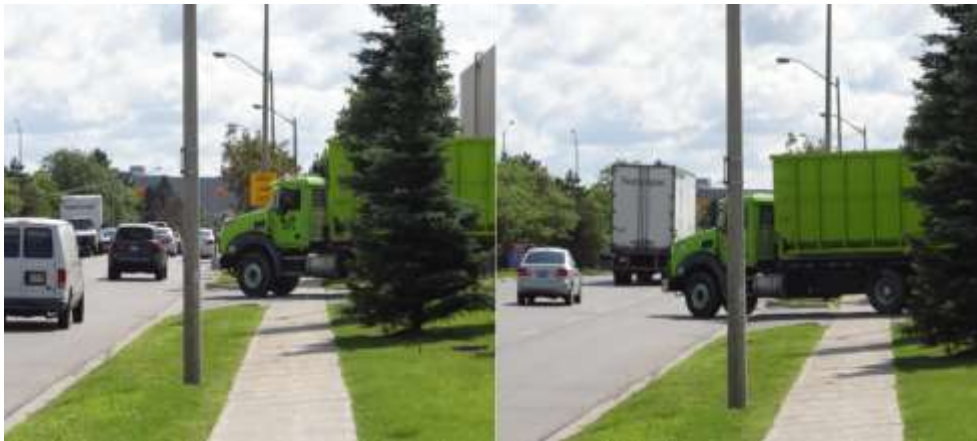
Figure 7 : Obscured Right Lane Exits Sign

Faded pavement markings along Portage Parkway and the wide exclusive right turn lane appear to be contributing factors to motorists being unaware of the existing lane configuration causing unsafe passing maneuvers within the intersection. A Right Lane Exits sign (Wa-56R) has been installed approximately 170 meters west of the intersection to inform the drivers of the exclusive right turn lane. However, this sign often becomes obstructed for motorists travelling in the eastbound direction along Portage Parkway. Heavy vehicles, entering and exiting a private driveway providing access to the loading bay of LOWE'S Home Improvement Warehouse, frequently obstructs this sign (installed in the close proximity of the eastside of the driveway) for the eastbound traffic causing motorists to miss the sign. The identified issue is illustrated in Figure 7.

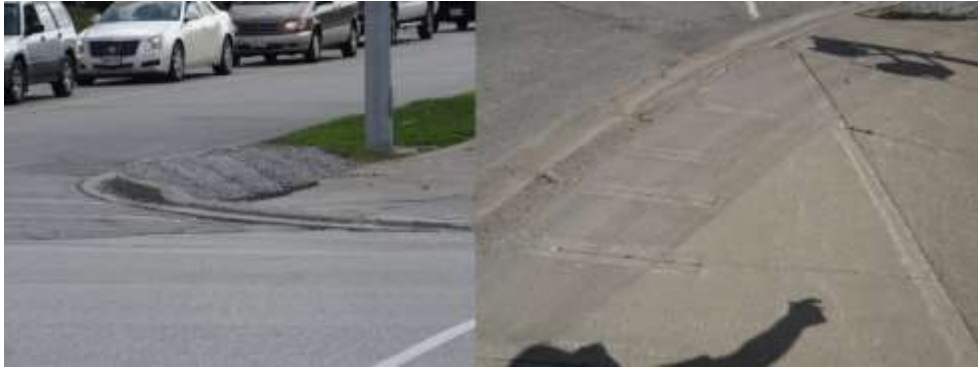
Figure 8 : Encroachment by Heavy Vehicles on Sidewalk

4.2.2 Limited Turning Radius for Heavy Vehicles

Heavy vehicles attempting to make a northbound right turn from Edgeley Boulevard onto Portage Parkway are forced to drive over the sidewalk and the grassy boulevard due to limited turning radius for heavy vehicles. This situation creates potential safety hazard for pedestrians on the southeast corner and is demonstrated in Figure 8. The left photo shows the eroded grassy boulevard (covered by gravel by the City's maintenance) due to repeated encroachment by trucks. The right photo shows the tyre marks on the pedestrian ramps at the crosswalks.

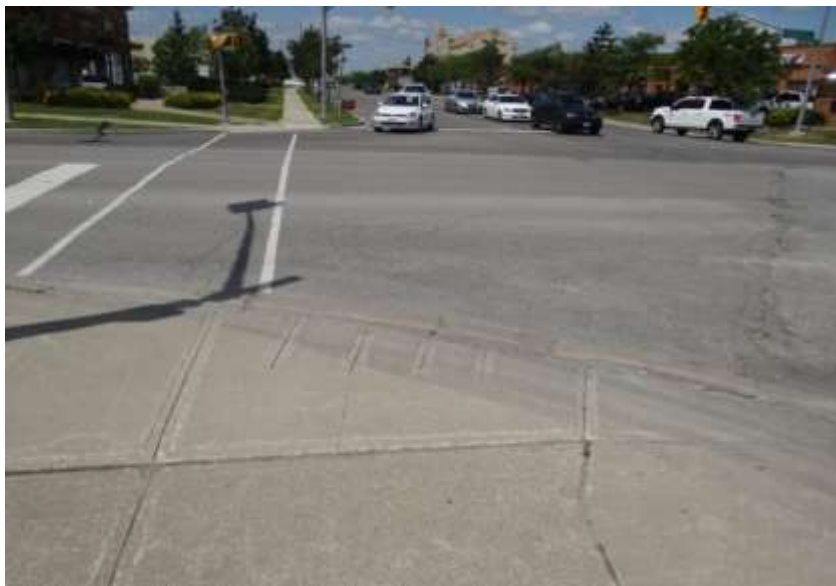
Figure 9: Tactile Surface at Curb Ramps not aligned with Crosswalks

4.2.3 Pedestrian Crosswalks not Aligned with the Tactile Surface of Ramps

The tactile surface provided at some existing curb ramps (for accessibility) are not aligned with the crosswalks as demonstrated in Figure 9. These curb ramps do not provide pedestrians who are visually impaired a safe route to cross the signalized intersection with some directing pedestrians into the traffic creating hazardous condition as shown in Figure 9.

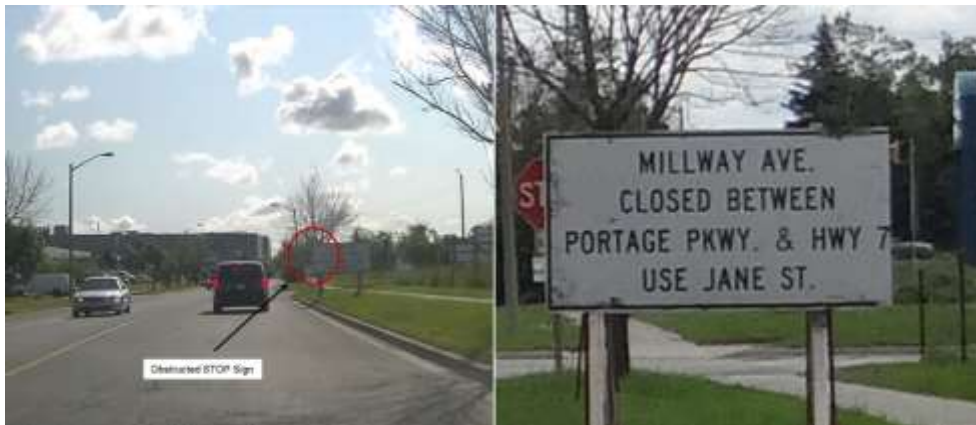
Figure 10: Obstructed STOP Sign in Eastbound Direction

4.3.1 Hidden All-Way Stop Sign

A Temporary Street Section Closed Sign installed upstream of the intersection of Portage Parkway and Millway Avenue in the eastbound direction (informing the closure of Millway Avenue) obstructs the existing STOP sign with ALL-WAY tab as demonstrated in Figure 10.

- + Increase the lateral offset of the temporary Street Section Closed Sign.

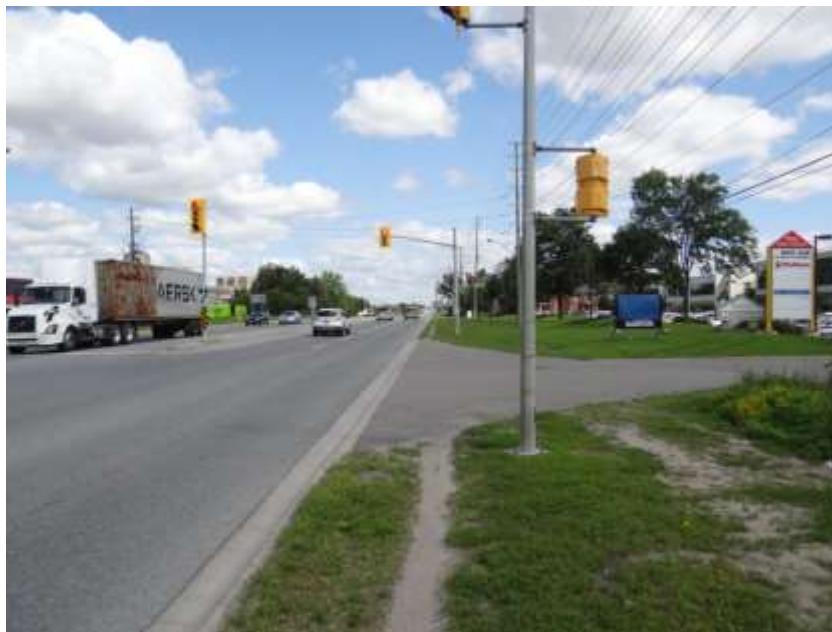
Figure 11: Pedestrian Path on East Approach Looking North

4.4.1 Lack of Pedestrian Infrastructure

Pedestrian's desire paths along with existing pedestrian signal heads indicate significant pedestrian activity along east and west sides of Jane Street. Limited street lighting in the area and lack of sidewalks may place pedestrians at risk while travelling by foot along Jane Street.

- + Improve pedestrian infrastructure at Jane Street and Portage Parkway including improvements to the bus stop located on the southeast corner of the intersection of Jane Street and Portage Parkway by providing appropriate sidewalk, curb ramps, shelter, and a concrete pad; and
- + Provide a Street Name Sign for the northbound traffic on the right side of Jane Street.

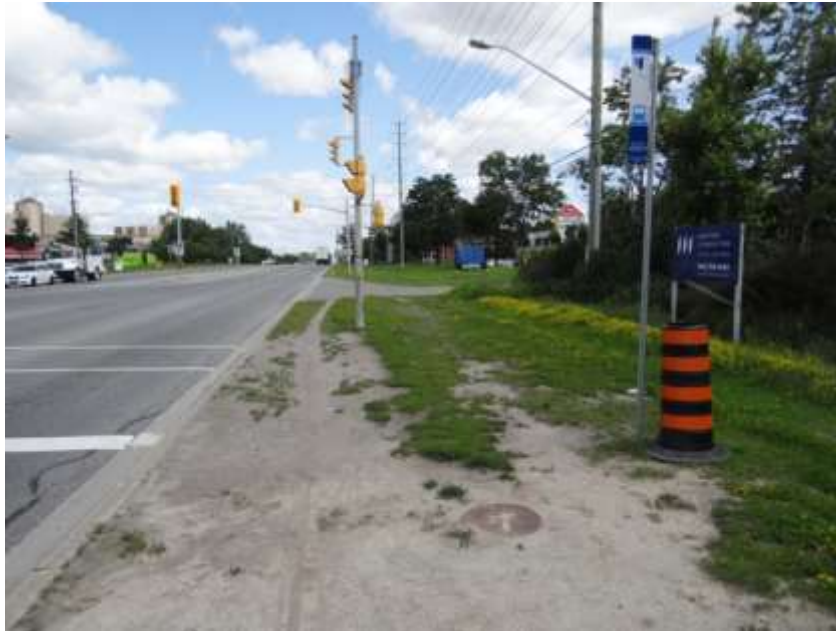
Figure 12: No Curb Ramp, Sidewalk, Concrete Pad, and Shelter at the Bus Stop (Looking North)

4.4.2 Limited Access to Bus Stop

The bus stop located on the southeast corner of the intersection of Jane Street and Portage Parkway is not accessible. A painted crosswalk exists on the south approach. However, due to lack of a sidewalk on the east approach of the intersection, curb ramps for providing access to

wheelchairs/scooters etc. do not exist. In addition, a concrete pad or a pedestrian shelter is not available. The issue is illustrated in Figure 12.

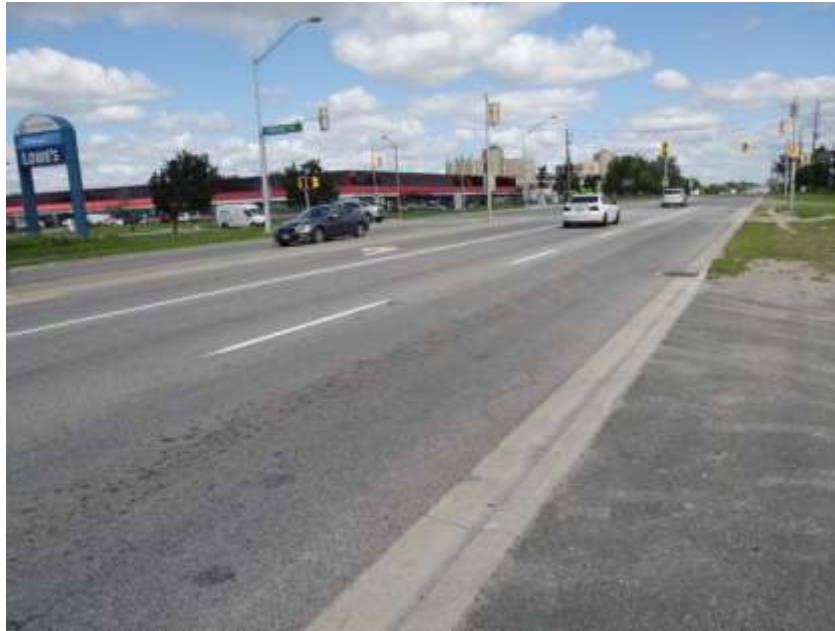
Figure 14: Street Name Sign Only Located on the Left Side (Looking North)

4.4.3 Missing Street Name Sign for Northbound Traffic

Existing street name sign in the northbound direction informing motorists of Portage Parkway is currently only located along the west side (adjacent to the left-turn lane) of Jane Street as demonstrated in Figure 14 making it difficult for motorists who are unfamiliar with the area to identify Portage Parkway.
