**Appendix 1A**  
**Preliminary Master Stormwater Management**  
**Strategy Report (Sernas 2009)**

# PRELIMINARY MASTER STORMWATER MANAGEMENT STRATEGY REPORT

## OFFICIAL PLAN AMENDMENT (OPA) 620 STEELES CORRIDOR – JANE TO KEELE LANDS CITY OF VAUGHAN

August 2009  
06452

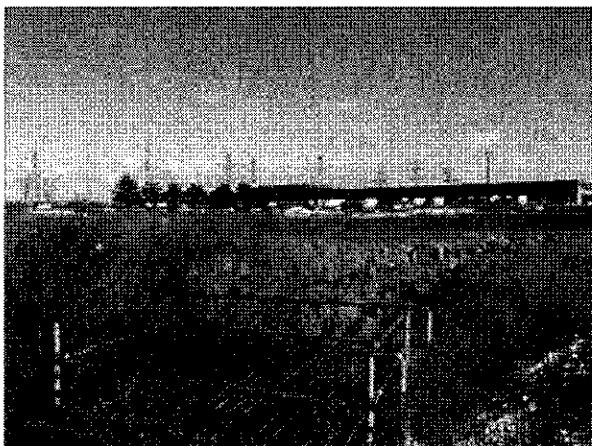
Photo 10: View of SWM pond from atop the headwall.

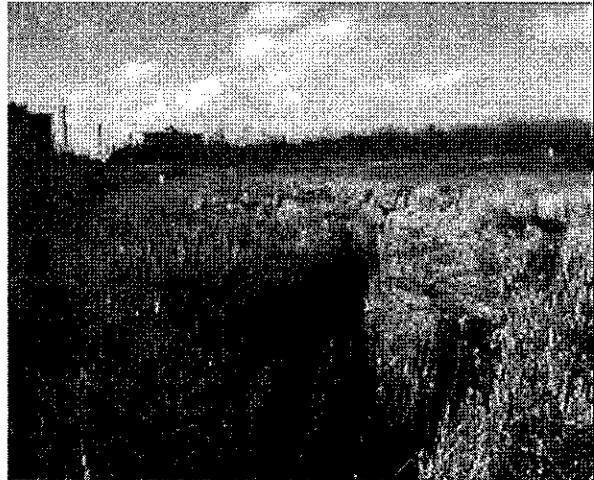
Photo 12: View from input headwall, looking across the cattail-lined pond.
