**Environmental
Assessment
Study for Portage
Parkway (Part A
and B)**
Safety Review of Existing
Conditions

B000541

August 2015

City of Vaughan

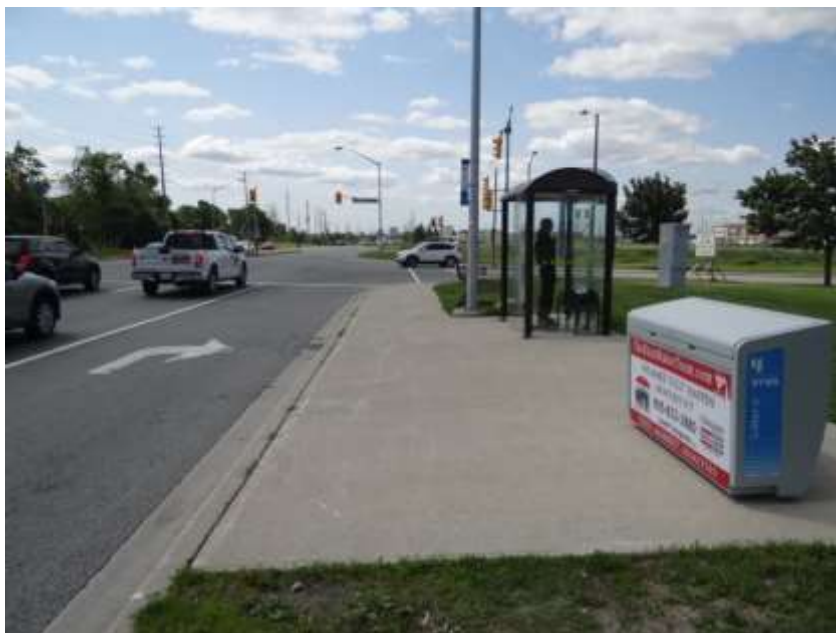
Figure 13: Improved Bus Stop on the Northwest Corner (Looking South)

It should be noted that the bus stop located on the northwest corner is provided with appropriate infrastructure as demonstrated in Figure 13.
